### Product(s) Affected:

PreciseFlex 400 robots with serial number label date range of 2507 – 2509 and serial label revision of 1A.

### Purpose of this TSB

This TSB notifies customers of error -3101 that may occur with the PreciseFlex 400 robots that were manufactured from July 2025 – September 2025. This notice provides instructions on how to edit the setup parameters to resolve the issue.

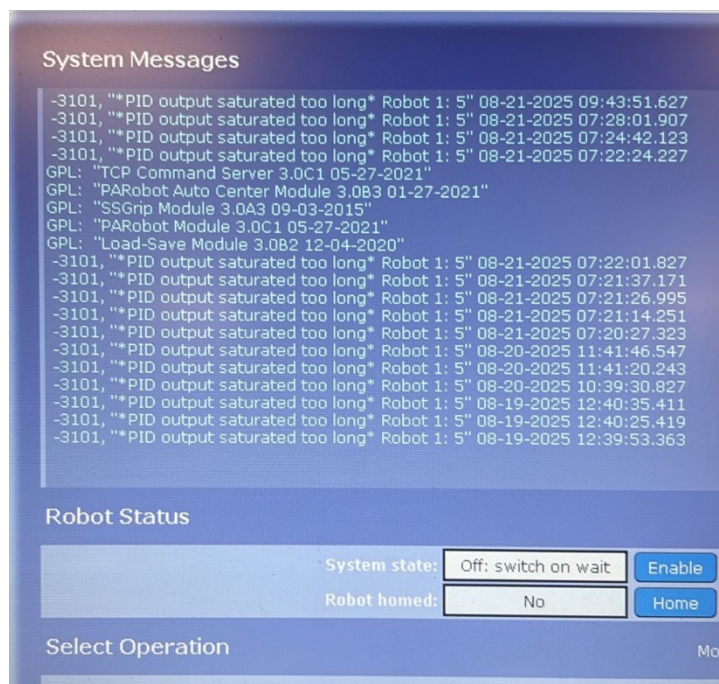
While operating the IntelliGuide s23 or v23 gripper on a PreciseFlex 400 robot, high power to the amplifiers may unexpectedly turn off, resulting in the error -3101 “PID output saturation too long” being reported. The -3101 error can be confirmed as the cause by accessing System Messages in the web-based operator interface.

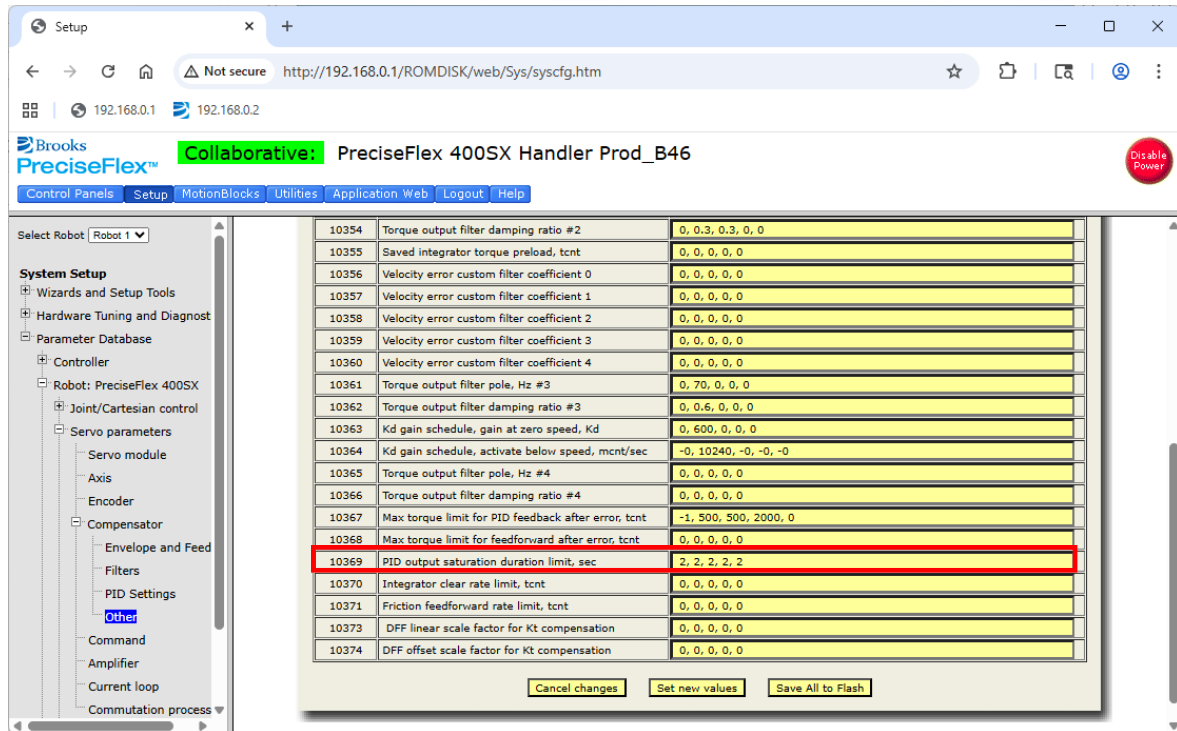
Figure 1: Factory Values for 10369 that cause -3101 Error

The problem is traced to incorrect parameters in the 10369 “PID output saturation duration limit, sec” field as shipped from the factory for PreciseFlex 400 robots manufactured during the timeframe of July 2025 – September 2025. Values as shipped from the factory were: 2, 2, 2, 2, 2

The issue has been corrected as of September 2025 with the release of new PAC files. The customer can fix the issue by manually updating the System Setup parameters for Data ID#10369 to be: 0.2, 0.2, 0.2, 0.2, 0.

1. Access the web-based operator interface for the robot – screenshots on following page.
2. Navigate to: Setup>System Setup>Parameter Database>Robot: PreciseFlex 400SX (or PreciseFlex 400SXL)>Servo parameters>Compensator>Other and locate data ID “10369 PID output saturation limit, sec”
  - Figure 1 illustrates the problematic factory values of 2, 2, 2, 2, 2
3. Edit the values to be: .2, .2, .2, .2, 0
4. Select [Set new values]
5. Select [Save all to Flash]
  - Figure 2 illustrates the updated settings.
