Technical Support Bulletin

TSB-1311

IntelliGuide v23/ v60 LED PCBA Replacement

Product(s) Affected: IntelliGuide v23 and v60 products

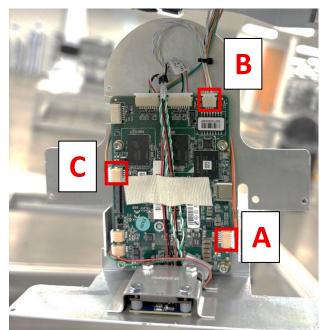
7. Disconnect the following slip-ring plugs from the IntelliGuide vision processor connectors

- A: 24 VDC Power Input (6 pin)
- B: Ethernet (4 pin)
- C: Digital Output (5 pin)

Step **Action** 6. Loosen the 4x M2.5-6 SHCS with an M2 hex driver and lift the IntelliGuide vision processor board up enough to clear connector A from the sheet metal tab
